Maryland Inventory of Historic Properties Historic Bridge Inventory Maryland State Highway Administration Maryland Historical Trust

SHA Bridge No. M 98 Name: Havilands Mill Road over Hawlings River

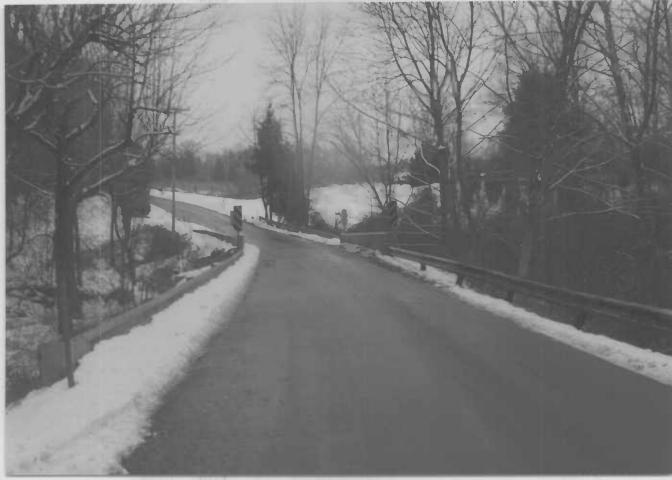
Name M98 - HAVILANDS MILL ROOKER H County/State Montgomery Imp Name of Photographer FRANK JULIANO Date 295	RIVER
Location of Negative	
Description APPROACH WEST	
1 4

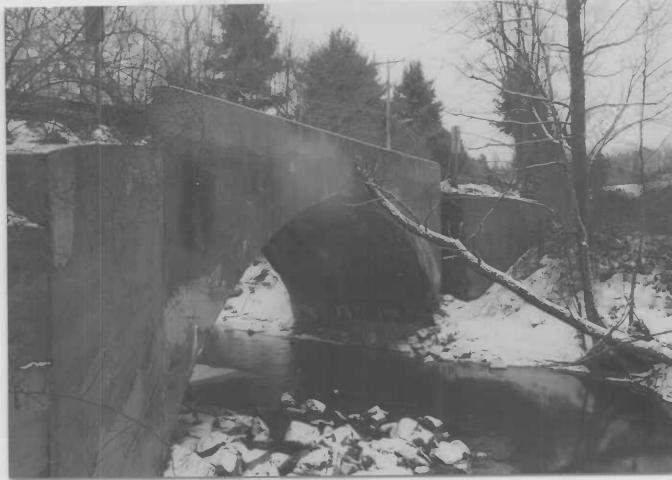
inventory # $\frac{m_2 t_3}{t_1}$
Name Ma8 - HAVILANDS MILLERO OVER HAWLING RIVE
County/State MONTGOMERY MD
Name of Photographer FRANK JULIANO
Date 2 95
Location of Negative SHR
Description ELEVATION SOUTH
Number 16 of 38
Number 10 of 20

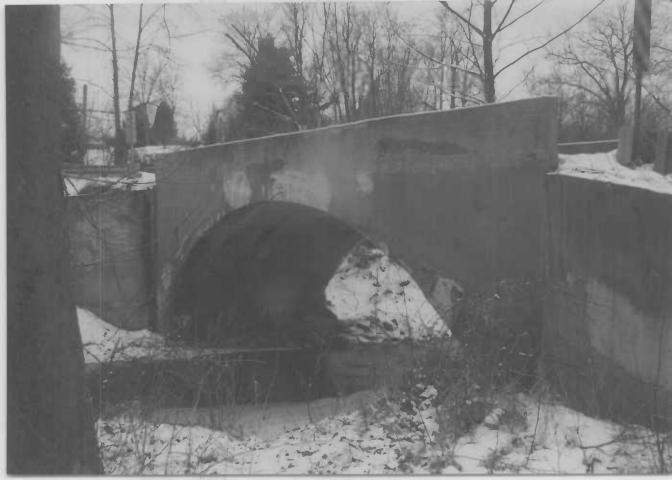
Name M98 - HAVILANDS MILL RO OVER HAWLINGS RIVER County/State Montoomery / mo Name of Photographer FRANK JULIANO Date 295
Location of Negative SHP
Description ELEMNON WORTH
34 4
Number 9 of 35

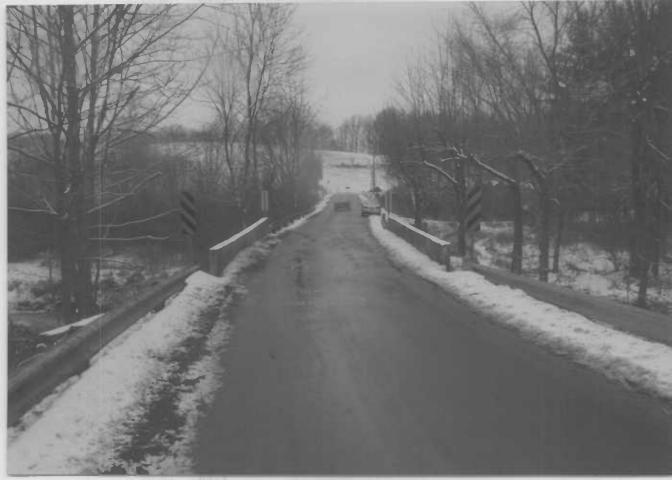
Name M98-HAULANDS MILLRO OVER HAWLINGS RIVER County/State Montgomery MD Name of Photographer FRANK JULIANO Date 295
Location of Negative
Description APPROACH EAST
4 4 Number 1 of 35
